Sofia Water Tank Inspection Report

General

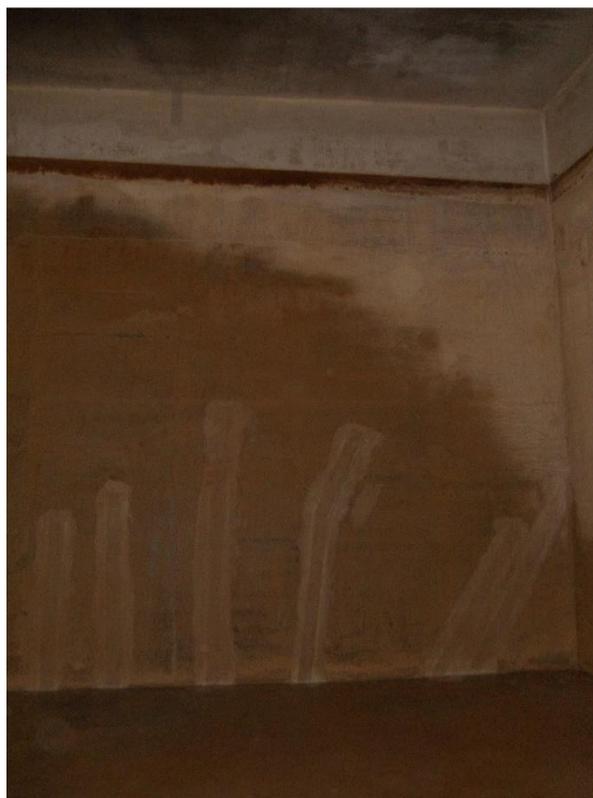
Image 1 - Repaired Cracks

- c. Epoxy injection crack sealing- where observed cracks exceed 0.8mm, inject NSF 61 certified epoxy grout sealer into cracks in accordance with the manufacturer’s instructions.

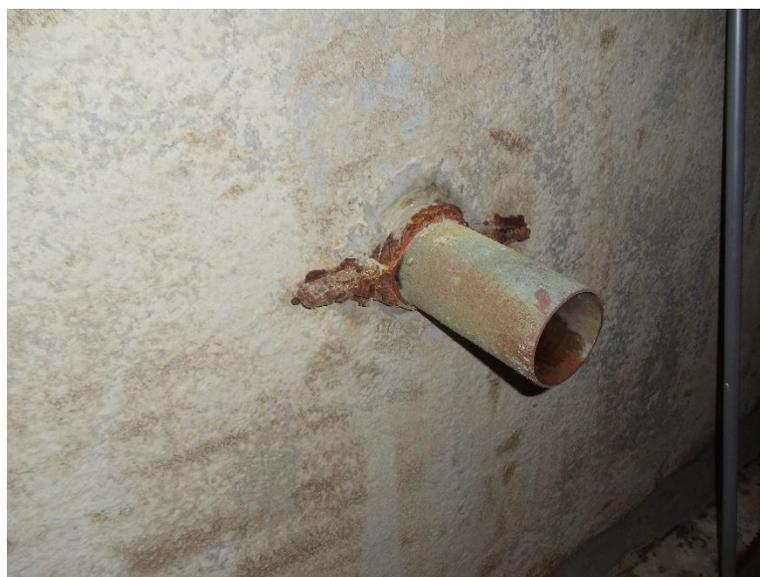
Image 2 - Recirculation intake penetration

4. Pipe penetrations- remove all external sealant applied to pipe penetrations inside tank. Clean, apply corrosion inhibitor and paint seal clamps and clamping hardware or replace as necessary. Reapply external sealant to cleaned opening.

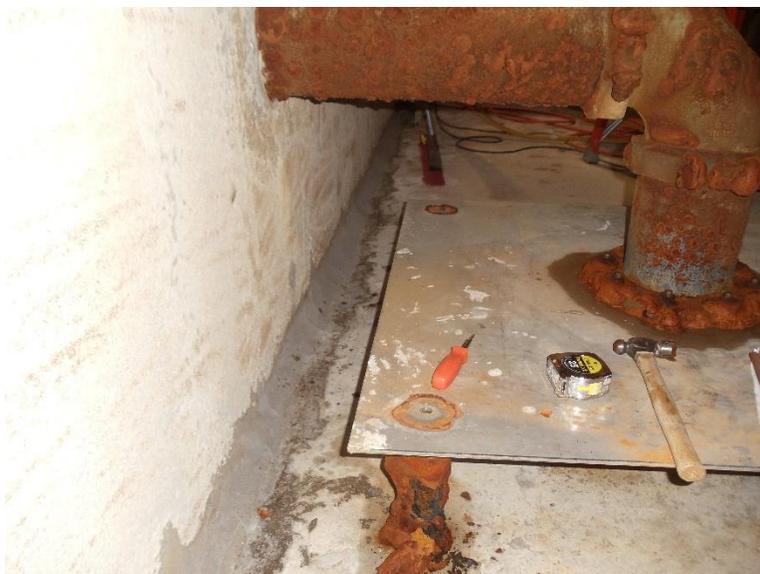
2. Fire pump anti-vortex plate supports- The supports under the anti-vortex plate have corroded and are no longer attached to the plate. They are generally in poor condition and should be replaced.

3. Fire pump intake pipe- The intake pipe for the fire pump is corroded, particularly where it attaches to the anti-vortex plate. The pipe should be cleaned, coated with a rust inhibitor and coated with an NSF 61 certified paint. After cleaning and before painting, bolts attaching the anti-vortex plate should be inspected. Bolts exhibiting excess material loss should be replaced. An improved arrangement would be to create a di-electric break between the plate and pipe using a rigid Teflon gasket and Teflon washers between the plate and pipe. Alternately, cathodic protection in the form of a zinc anode could be attached to the inlet pipe.

Image 3 Fire Pump Inlet

2. Fire pump anti-vortex plate supports – Replace anti-vortex plate support with new supports fabricated of 316-D stainless steel or other corrosion resistant material.

3. Fire pump anti-vortex plate attachment bolts – clean and descale fire pump intake pipe. Examine and replace bolts exhibiting excess material loss. Consider installing di-electric break between plate and pipe, or zinc anode on pipe to prevent corrosion. Pipe should be coated with corrosion inhibitor and painted with an NSF 61 approved paint.

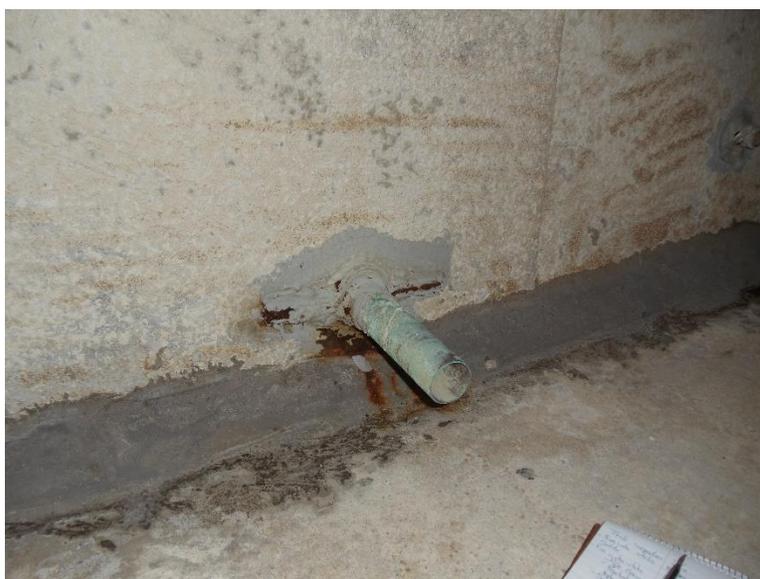
Image 4 - Water level Pipe Penetration

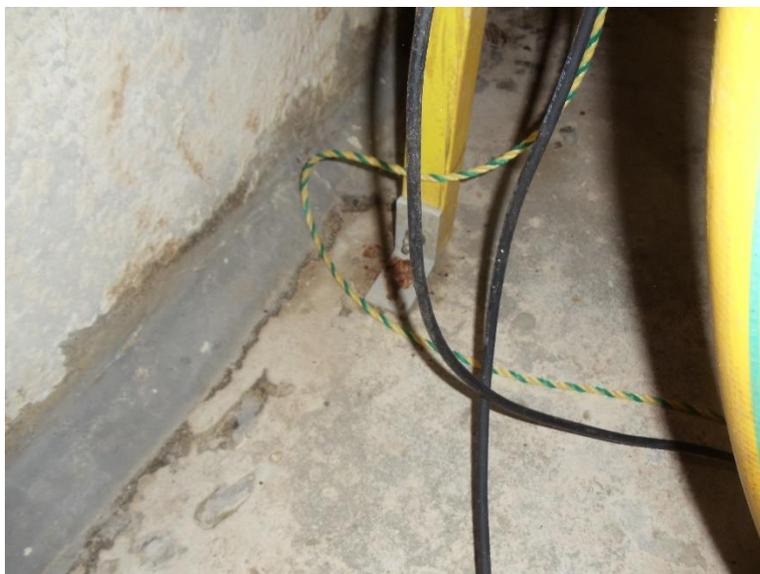
1. Ladder anchor bolts corroded- The ladder was installed using either low quality stainless steel or carbon steel anchors. These have corroded and should be replaced.

Image 5 - Corroded ladder anchors

1. Repair access ladder mounts – remount access ladders with 12.5mm drop in anchors fabricated of noncorrosive material such as 316-d Stainless steel, or phosphor bronze. Drop-in anchors should have a minimum pullout strength of 250 kg and a shear strength of 500 kg. Anchors should be installed in accordance with manufacturer’s instructions.

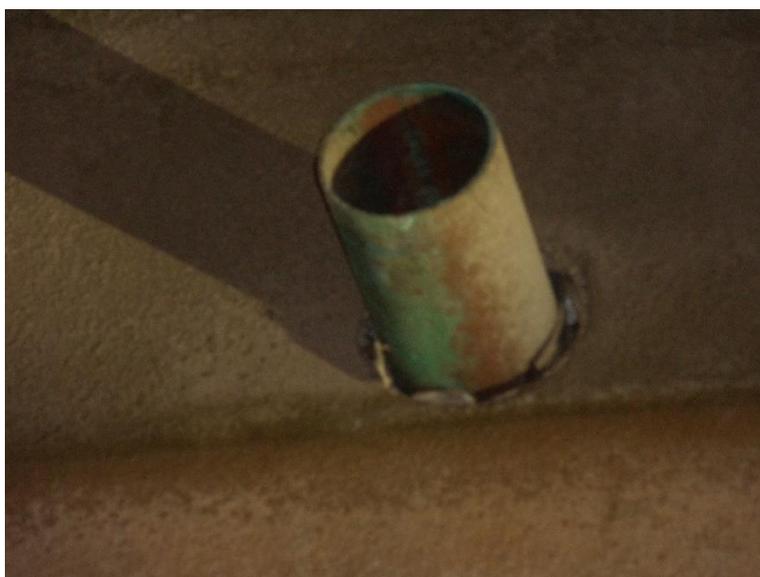
4. Tank vent- The tank vent pipe penetration in tank 1 did not appear to be properly sealed. This penetration should be sealed to prevent infiltration into the tank. Similarly, the vent riser seal has deteriorated and should be replaced on both tanks.

Image 6 - Unsealed vent / overflow

5. Install sealant to vent pipe penetration- Install sealant to vent pipe penetration from interior and exterior of tank.
6. Inspect and replace electrical lighting circuit within tank – Open boxes and inspect wiring connections. Replace corroded connections, fixtures, boxes, etc. Install new weather seals on boxes to remain.

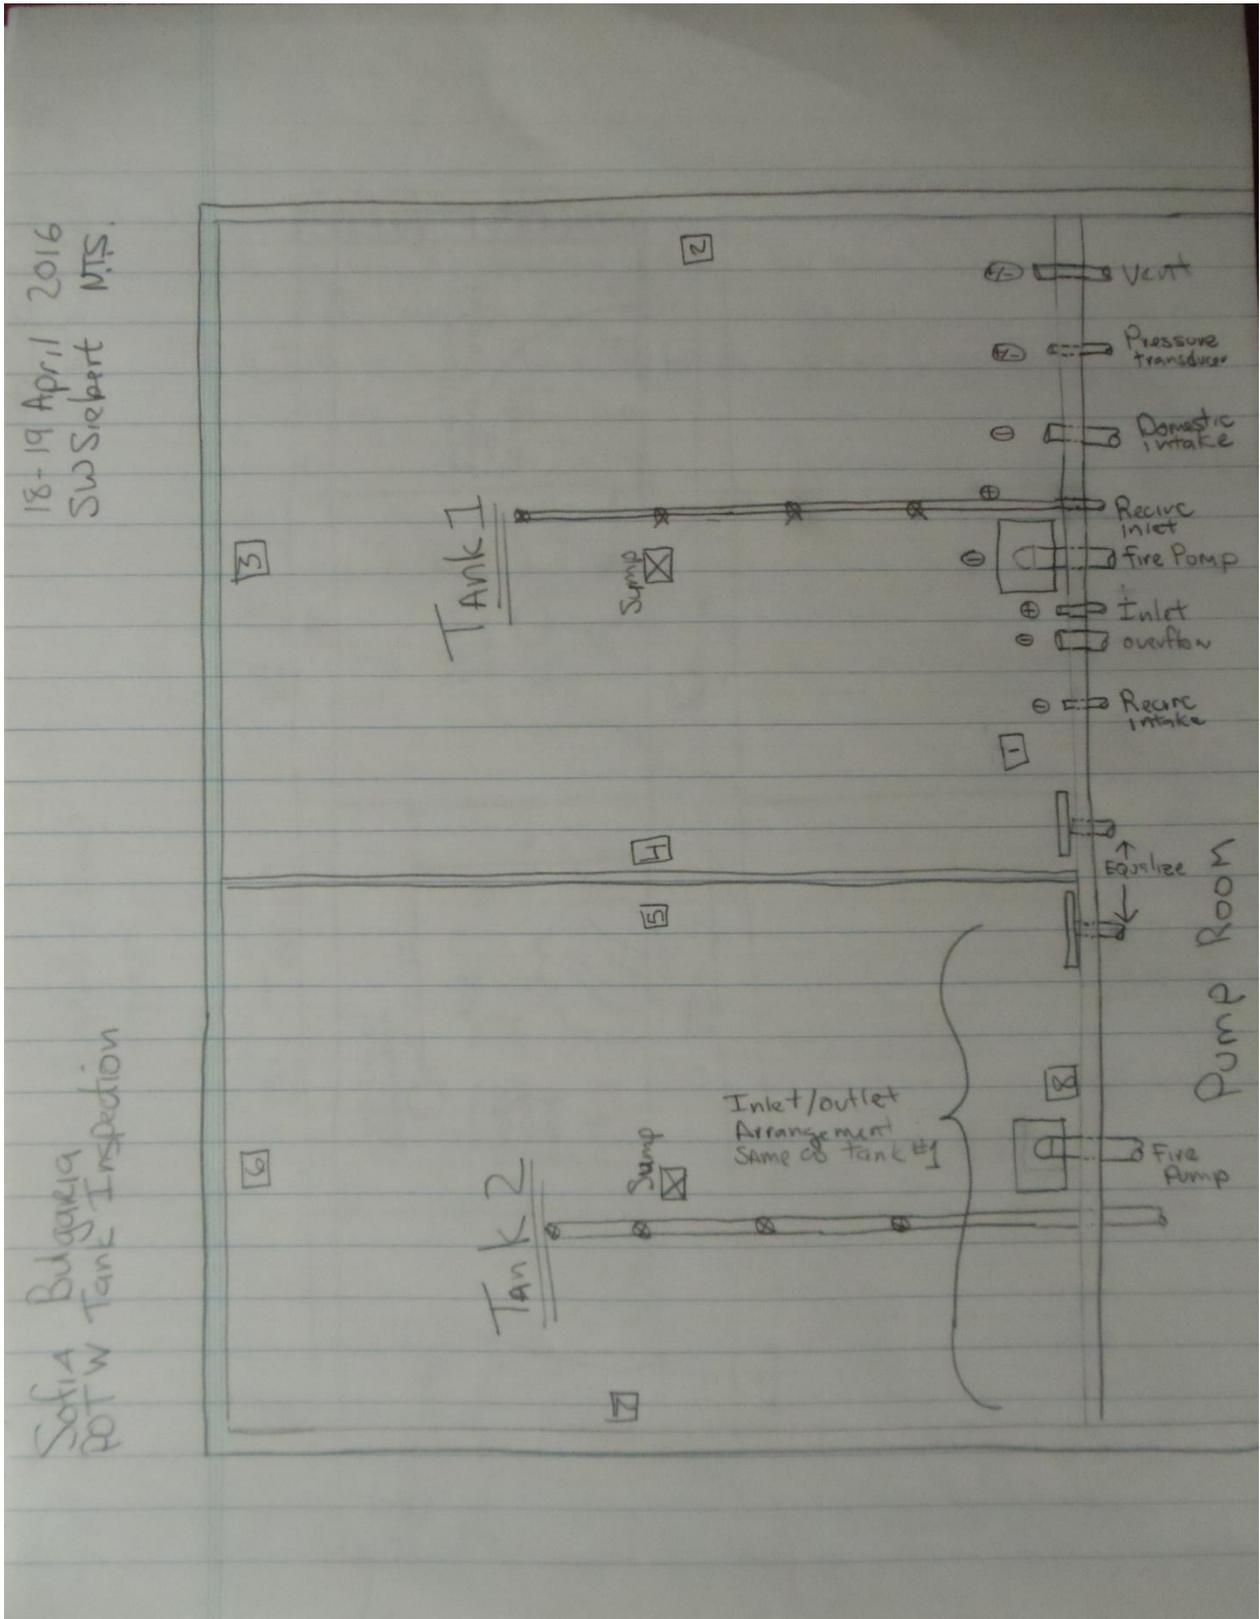
Tank Exploded View
Sofia Bulgaria

7. Tank Structure- The tank structure was found to be in good overall condition. Several locations were found where concrete delamination around rebar were detected. In all of these areas, the concrete remained sound with no evidence of spalling observed. These areas are shown in the attached sketch. Evidence of past crack repairs were observed. These repairs consist of the application of additional brushed on cementitious sealer with and without woven fabric reinforcement. Evidence of delamination of the crack repairs were observed. Cementitious crack seal was applied along the entire joint between the wall and floor on the wall adjacent to the pump room. Evidence of seepage through this wall on the pump room side was observed.
